PENNSYLVANIA
EDINBORO LAKE DAM

NDI ID NO. PA-18
DER ID NO. 25-4

BOROUGH OF EDINBORO
PHASE I INSPECTION REPORT
NATIONAL DAM INSPECTION PROGRAM

PHASE I REPORT
NATIONAL DAM INSPECTION REPORT

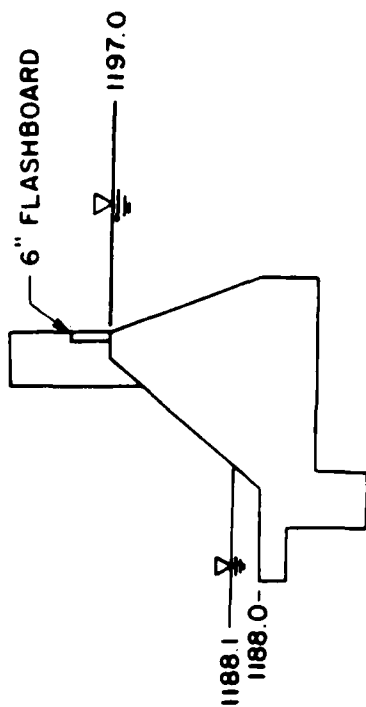
SPILLWAY SECTION
(NOT TO SCALE)

The concrete gravity section appeared to be in fair condition. No visible deficiencies were observed during the inspections. Flows over the spillway section during the October 20, 1980 inspection and heavy snow which covered the spillway section during the January 15, 1981 inspection hampered attempts to observe the downstream face and crest of the spillway section. The roadway bridge which spans the spillway crest is a relatively new structure and appeared to be in good condition.

1. A more detailed stability analysis of the gravity spillway section should be conducted by a Registered Professional Engineer knowledgeable in dam design and construction in conjunction with a detailed hydrologic and hydraulic analysis of the structure to increase spillway capacity and to assess the stability of the structure. Remedial modifications should be completed as indicated by the analysis.
2. A planned maintenance and operation schedule should be prepared and implemented. The plan should include regular inspections by responsible Borough employees to insure that routine maintenance is conducted at the dam.
3. A warning system should be developed to warn downstream residents of large spillway discharges or imminent failure of the dam.
4. A safety inspection program should be implemented with inspections at regular intervals by qualified personnel.

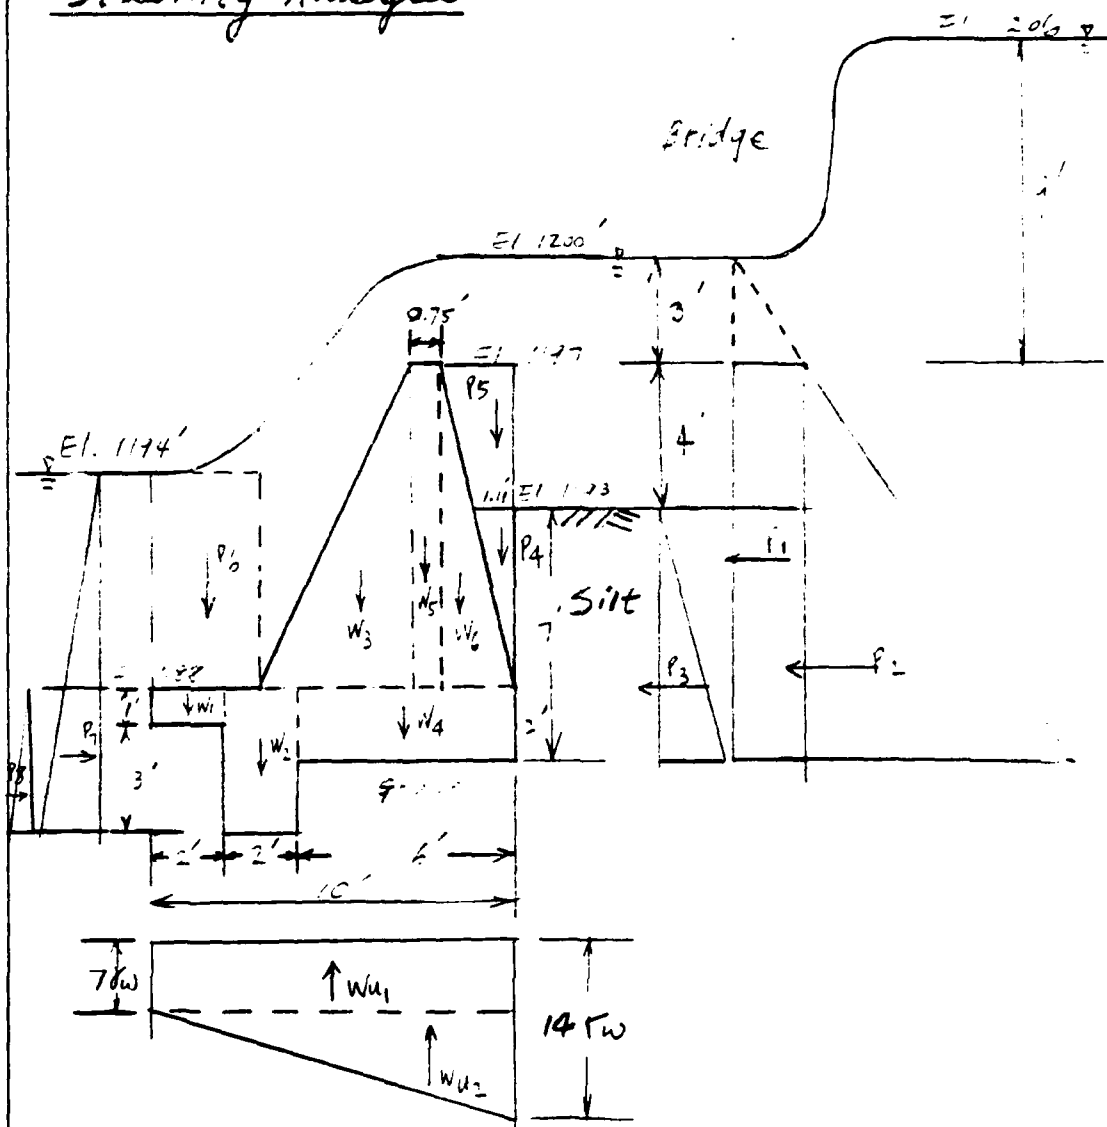
Stability Analysis

Based on the assumed conditions, the analyses revealed that the dam is unstable at the pool elevation considered. Factors of safety equal to 1.01 (sliding) and 1.08 (overtopping) resulted from the analysis. The results of the stability analysis indicate that the potential for failure exists at an elevation less than 1206.0. More detailed and accurate analyses are required.
